AERIAL PHOTOGRAPHIC ANALYSIS USN SUPPLY CENTER - CHEATHAM ANNEX

Williamsburg, Virginia

TS-PIC-9803364S
May 1998

D. R. Williams
Environmental Services Division
Lockheed Environmental Systems & Technologies Co.
Las Vegas, Nevada 89119

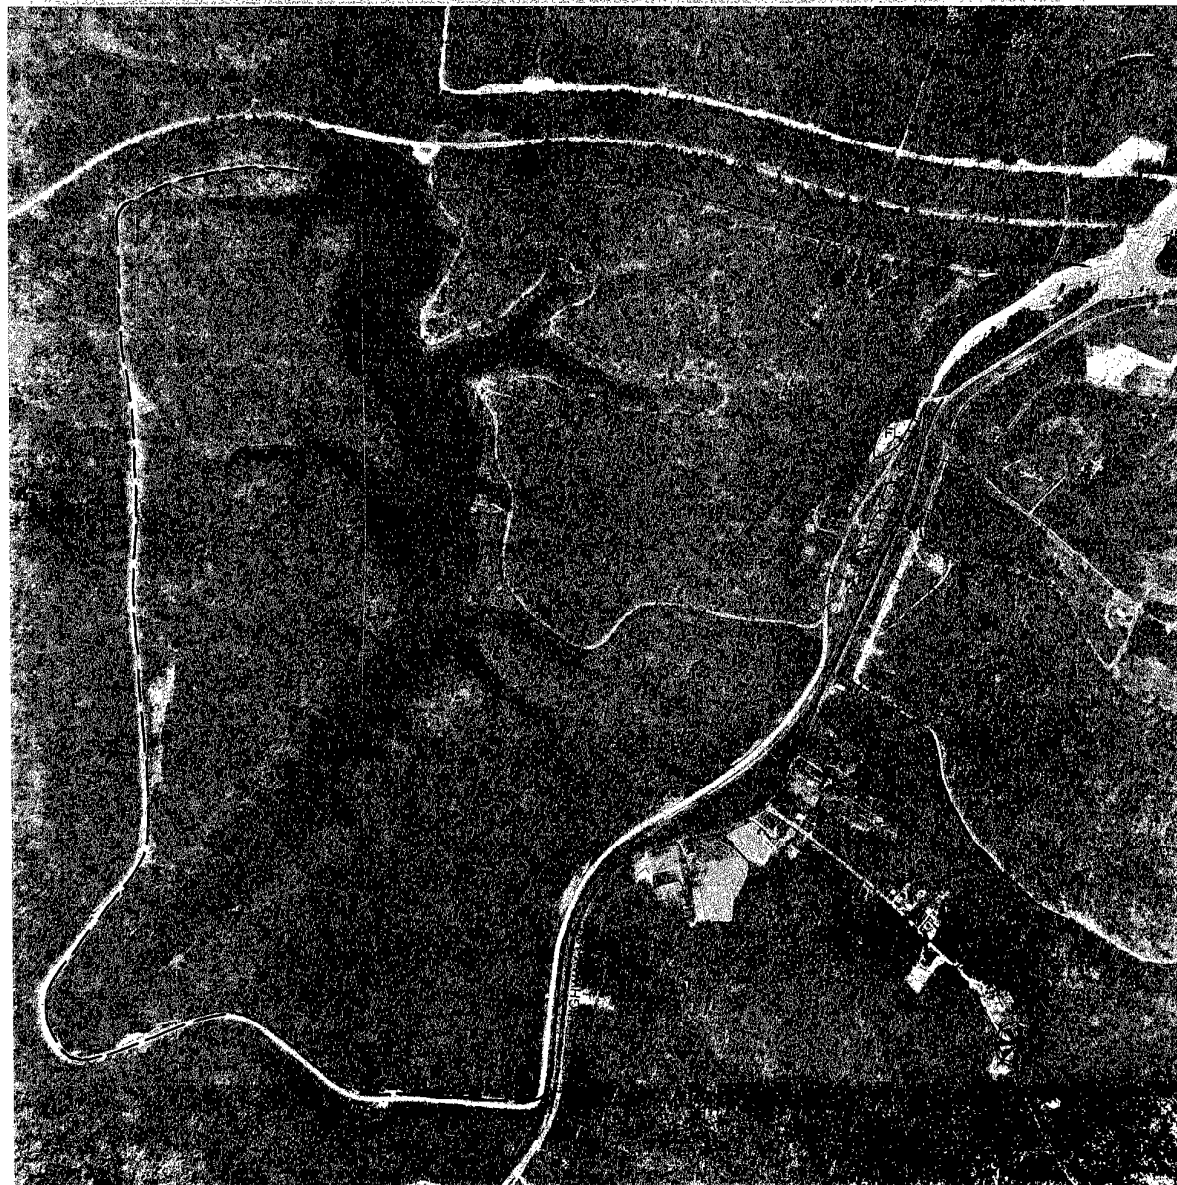
APRIL 3, 1963 (FIGURE 24)

A large deposit of fill is present at the north end of the railyard. To the south three additional deposits of fill, a small deposit of dark-toned material, and a large crane are noted. One large deposit of dark-toned mounded material is seen north of the water tower. The dark-toned material seen at AOC 12 in 1955 is no longer present.

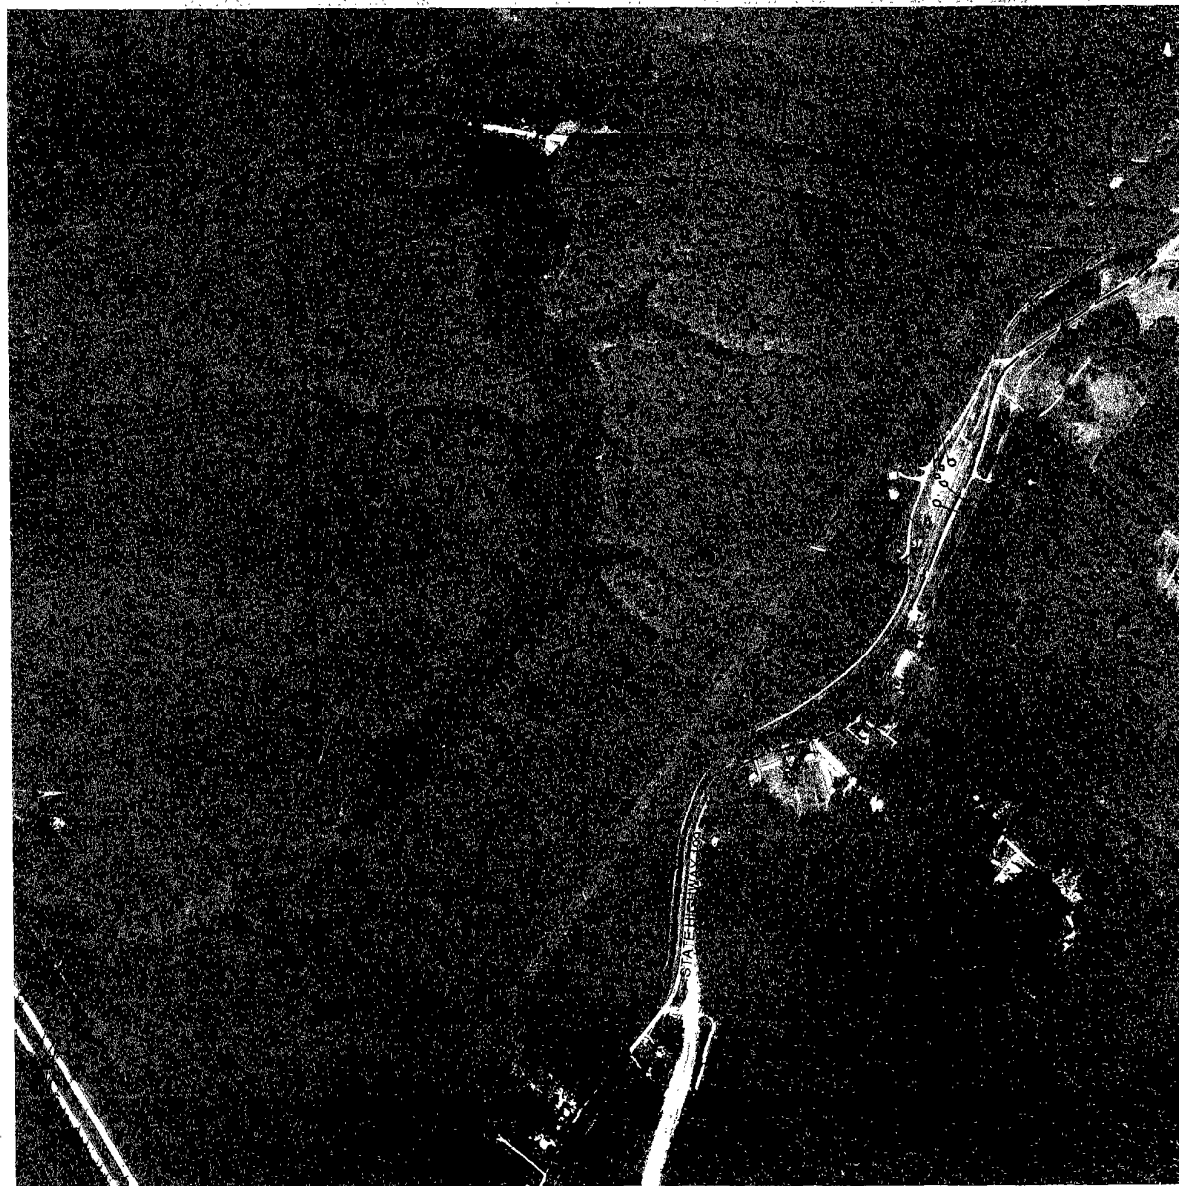
OCTOBER 23, 1975 (FIGURE 25)

Five small mounds of fill are noted north of the water tank. No significant features are associated with AOC 12.
